Bulletin No.: 05-06-01-022A

Diagnostic Information on LL8 Engine Oil Leak from Rear of Crankshaft Due to Porosity (Follow Special Crankshaft Porosity Service Repair Procedure)

2005 Buick Rainier

with 4.2L Inline 6 Cylinder Engine (VIN S — RPO LL8) and

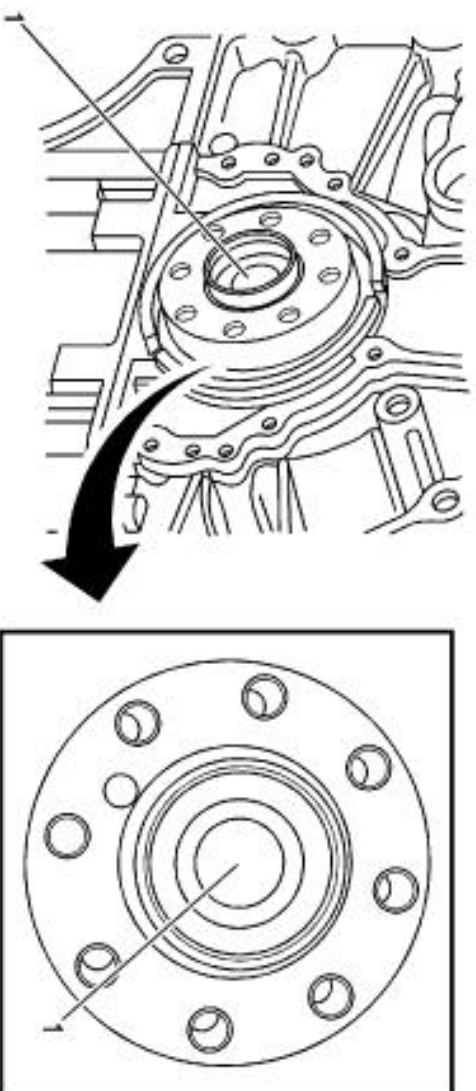
Special Crankshaft Porosity Service Repair Procedure

This bulletin is being published to aid technicians in the diagnosis and repair of oil leak from the rear of the engine. Some engines may have slight crankshaft casting porosity that results in a leak in the crankshaft flange bore. This leak may be misdiagnosed as a rear main oil seal leak.
