Bulletin No.: 05-06-01-022A

Diagnostic Information on LL8 Engine Oil Leak from Rear of Crankshaft Due to Porosity (Follow Special Crankshaft Porosity Service Repair Procedure)

Special Crankshaft Porosity Service Repair Procedure

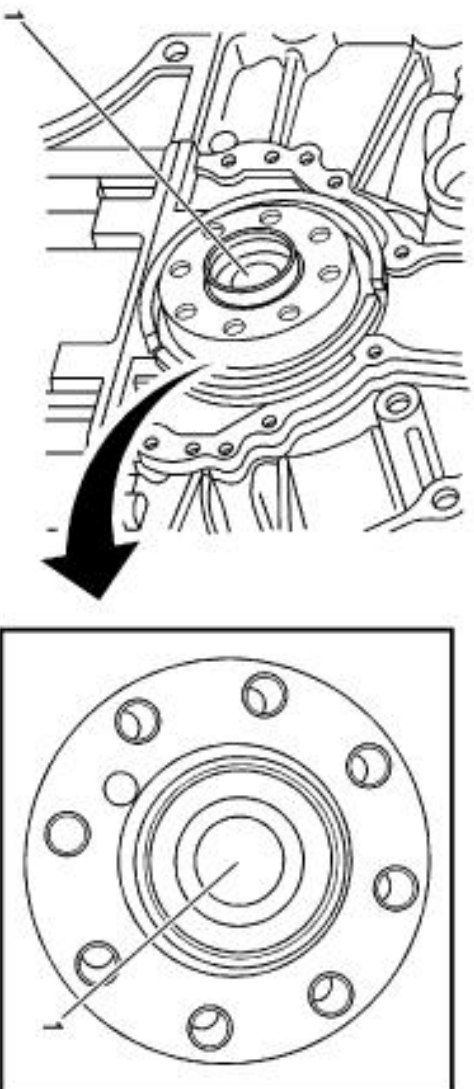
This bulletin is being published to aid technicians in the diagnosis and repair of oil leak from the rear of the engine. Some engines may have slight crankshaft casting porosity that results in a leak in the crankshaft flange bore. This leak may be misdiagnosed as a rear main oil seal leak.
